USING THE CURED-IN-PLACE PIPE PROCESS TO RENOVATE DETERIORATED UNDERGROUND PIPE WITH A BITUMINOUS COATING

By NASSCO Technical Advisory Council Member **Kaleel Rahaim**

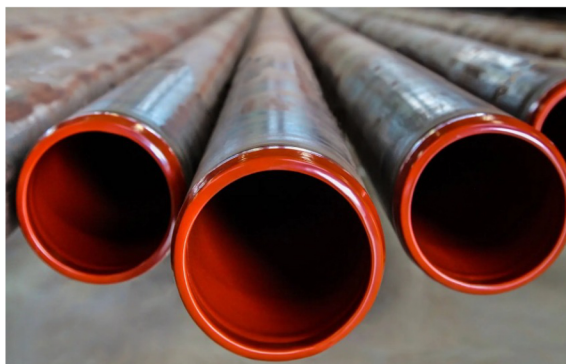
What is a bituminous coating on a pipe? A bituminous coating is a coating with material composed of asphalt and coal tar mixed with additives. Bituminous coatings are a complex mixture of hydrocarbons, both aromatic and aliphatic. It is applied to pipes to minimize corrosion and waterproof the surface of the pipe (Figure 1).

Figure 1. Pipe with a bituminous inner coating
